City of Redmond Crosswalk Site Review Worksheet

The proposed crossing location is on NE 76th Street between 185th Ave NE and 188th Ave NE. The proposed crossing is located to the west side of an existing driveway, on the south side of the road. The existing driveway is restricted to right turns in and right turn out by an existing center landscaped median. The driveway will provide future access to new development on the Union Hill Corporate Center, including the proposed Lot 4 (Union Hill Self-Storage & Costco Employee Parking). A vicinity map (Attachment 1) and a site plan (Attachment 2) are attached for reference highlighting the proposed crossing location.

The Applicant is proposing to provide a marked crosswalk on NE 76th Street to support Costco employees crossing the street between the proposed Costco Employee Parking, located on the south side of NE 76th Street, and the Costco Wholesale Membership Warehouse, which is currently under construction on the north side of NE 76th Street.

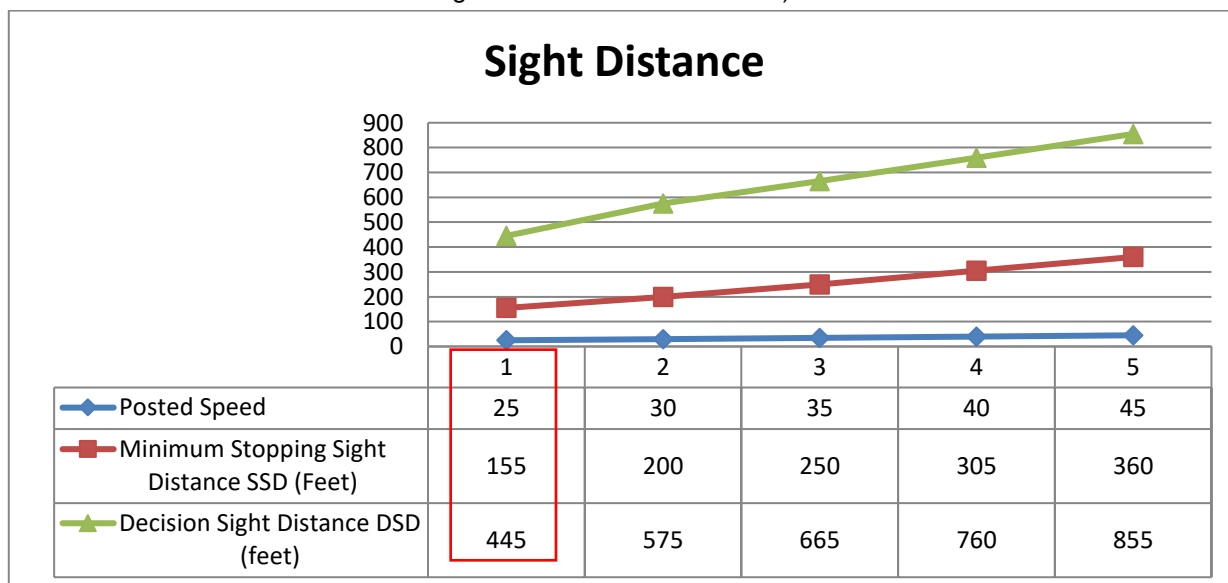
19) Sight Distance (DSD & SSD shall be determined using a driver eye-height of 3.5 feet and an object-height of 0.5 feet. An object height of two feet may be considered on a case-by-case basis for existing streets. Distances measured along the centerline of the street).

Redmond staff indicated that the legal speed on NE 76th Street is 25 mph. The current speed limit sign on NE 76th Street, is incorrectly posted at 35 mph. The following analysis is based on a 25 mph posted speed limit, as advised by Redmond staff (9/1/2016).

Sight distance requirements are highlighted in the above table. Attachment 4 shows the field measured sightlines. Table 2 summarizes the sight distance measures. Overall the sightlines are sufficient.

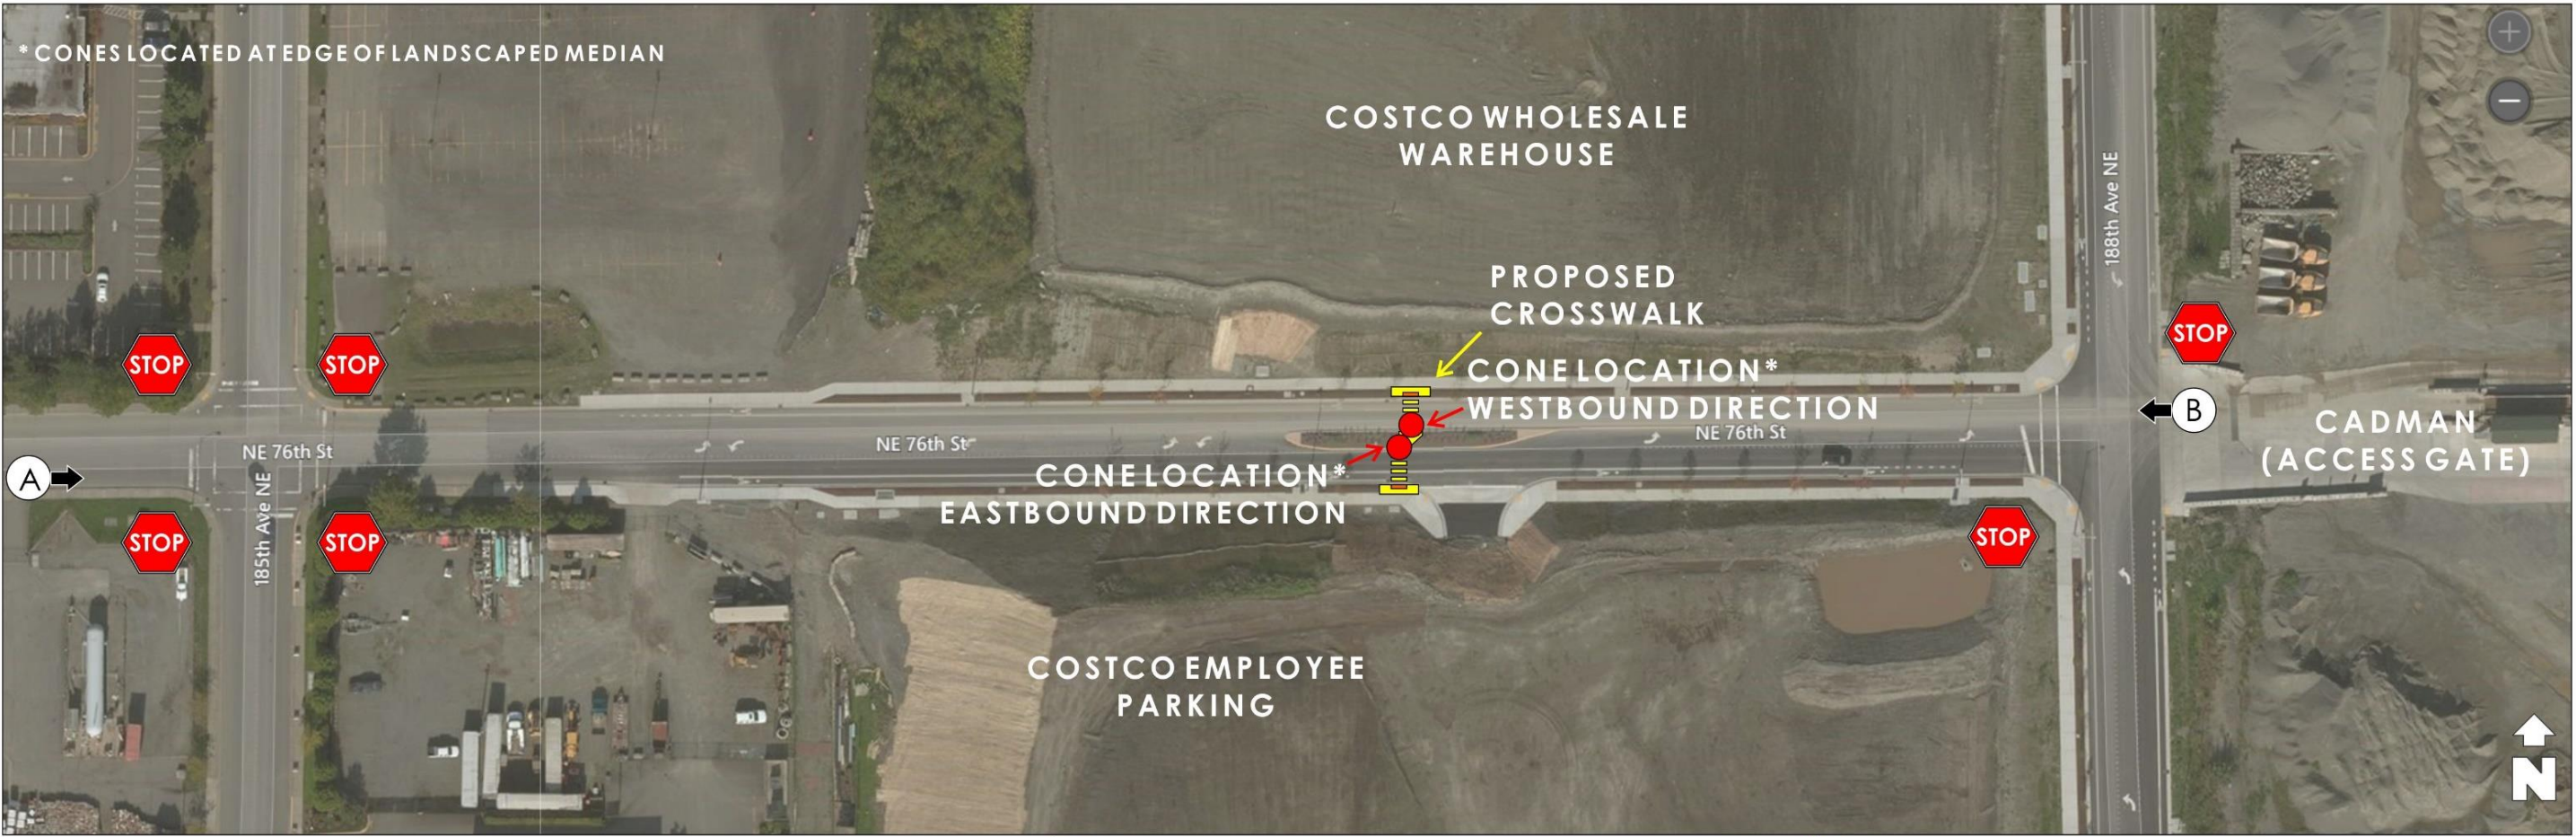
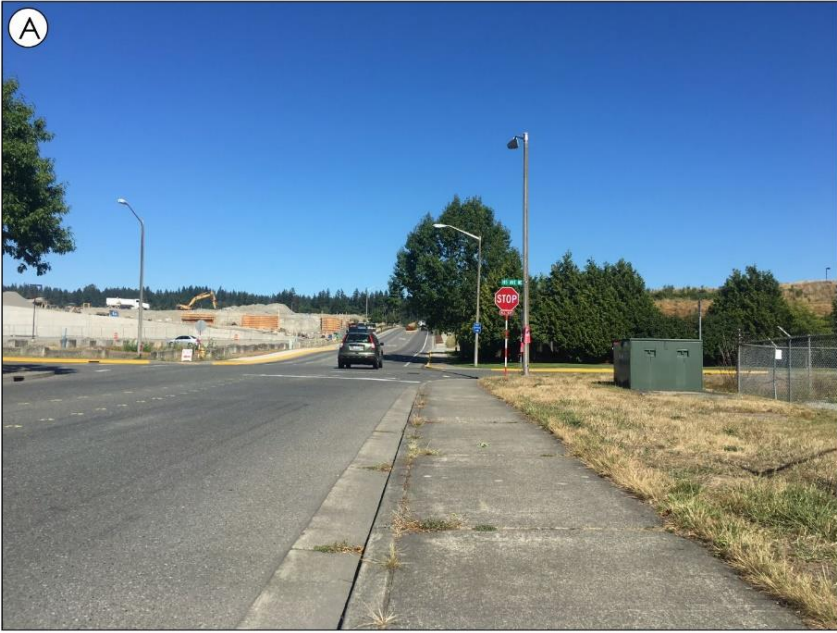
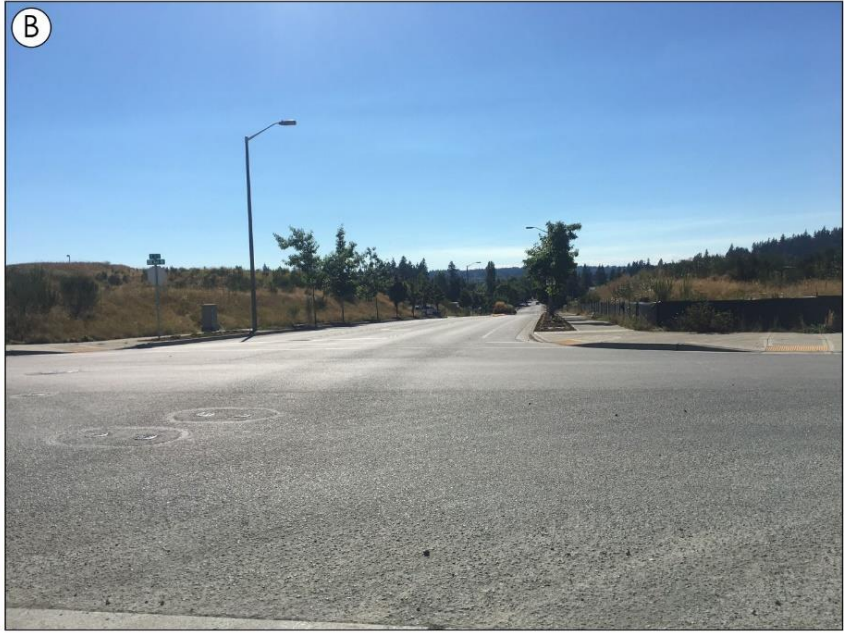
LOCATION	SIGHTLINE MEASURED	STOPPING SIGHT DISTANCE		DECISION SIGHT DISTANCE	
		REQUIRED**	OKAY?	REQUIRED**	OKAY?
A	740 FEET	155 FEET	YES	445 FEET	YES
B	470 FEET	155 FEET	YES	445 FEET	YES

** LEGAL SPEED IS 25 MPH, PER FEEDBACK FROM REDMOND STAFF.

*** THE PHOTOS REPRESENT THE FIELD DECISION SIGHT DISTANCE MEASURES LOOKING TO THE "CONE".

Location (Looking)	Sightline Measure (ft.)	Stopping Sight Distance (ft.)		Decision Sight Distance (ft.)	
		Required	Okay?	Required	Okay?
A (Eastbound)	740	155	Yes	445	Yes
B (Westbound)	470	155	Yes	445	Yes
